Análisis de la distribución del peso de la cúpula sobre los mecanismos de rotación del Very Large Telescope ubicado en el Observatorio Paranal, y desarrollo de un método de monitoreo de condición.

(“Analysis of the load distribution of the dome weight on the rotation mechanisms of the Very Large Telescope located at the Paranal Observatory, and development of a condition monitoring method.”)

Tesis para optar al grado de Magister en Ciencias de la Ingeniería con mención en
Ingeniería Mecánica

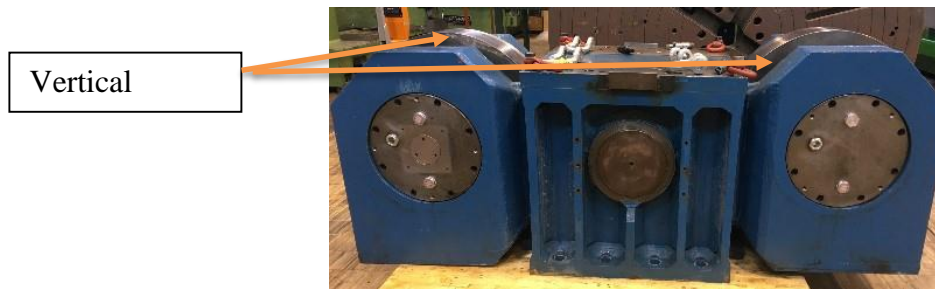
Figure 2. Bogie with the two vertical wheels.

The set of units allowing the rotation of the dome for night observations is called rotation mechanism (RTM) or bogies. The RTM consists in 8 bogies assemblies mounted to the lower (fixed) portion of the enclosure, each using two vertical wheels, one driven and one idle wheel. There are lateral guides between the vertical wheels constraining enclosure motion in radial direction. The rail is composed of built-up box-beams and machined running surfaces. Figure 2 and 3 show the bogie assembly.

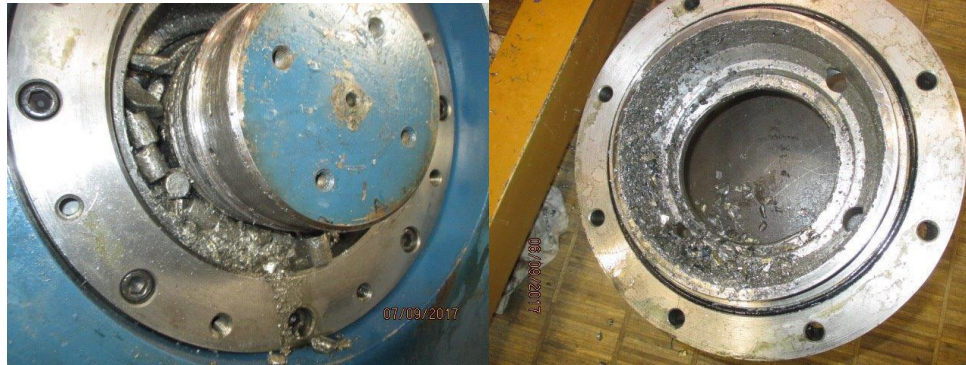
Figure 5. Bearing damage, UT4-RTM 2 (source: [ESO Workshop Paranal 2017]).

In September 2017 there was a catastrophic failure of RTM2 of the UT4 due to bearing damage (gear box side) of the idle wheel, which can be observed in Figure 5. The RTM had to be dismantled and replaced.

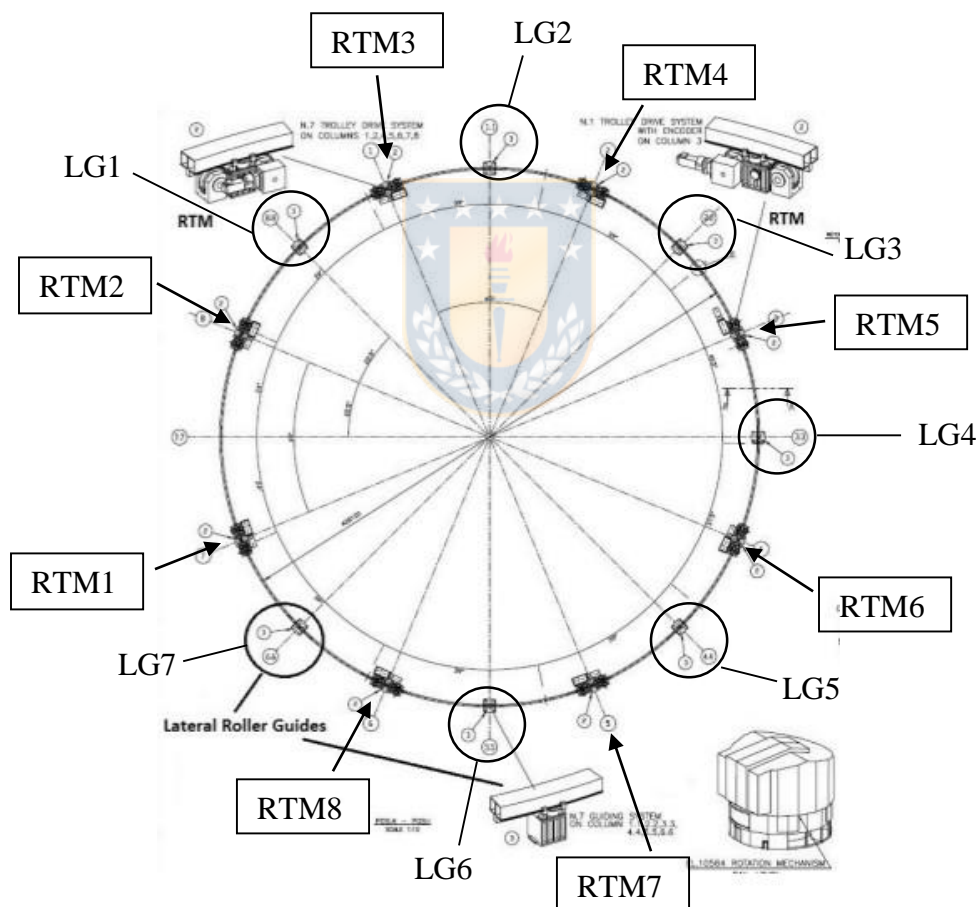
Figure 6. Design of the VLT enclosure rotating system in UT1 (source: [SEBIS-1 1994]).

Figure 6 shows that the VLT enclosure is supported on 8 bogies (RTM1 – RTM8) assemblies, each using two wheels which are slightly conical (1.13°). The wheel orientation is vertical and accordingly slightly inclined (1.13°) [Dome Bogies Workshop 2016]. The diameter of the wheels is 0.6 m and the width 0.125 m.

The VLT enclosure design is unusual because the bogies are mounted to the lower (fixed) portion of the enclosure and not to the upper moving portion. Fixed bogies appear to be used in case of relatively stiff and light-weight enclosures with uniform azimuthal load distribution. So cyclically-varying loads on the

bogie assemblies due to rotation of the enclosure are limited [Bigelow 2016]. Theoretically each of the 16 wheels carries an average load of 17.5 tons.

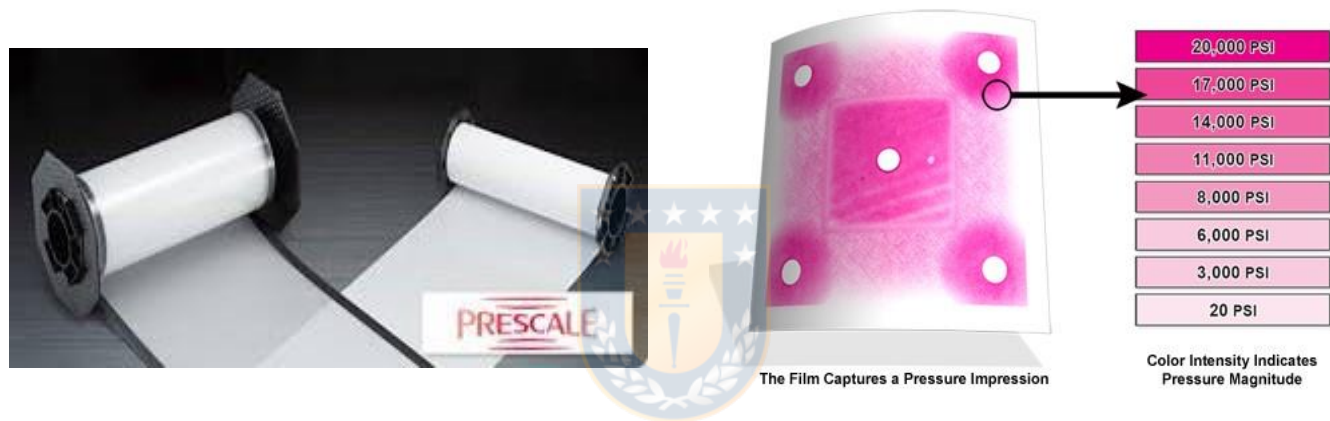
Figure 8. Fujifilm's Prescale pressure measurement film (source: [<https://www.fujifilm.com>]).

In [Rayo 2019] the use of Fujifilm's Prescale pressure measurement films is proposed for the analysis of the load distribution of the dome weight on the RTM. The films reveal the required information by measuring the contact pressure of the dome weight on the RTM and its distribution. Applied pressure differences between the vertical wheels and the rail are indicated as red color density variations, as shown in Figure 8.

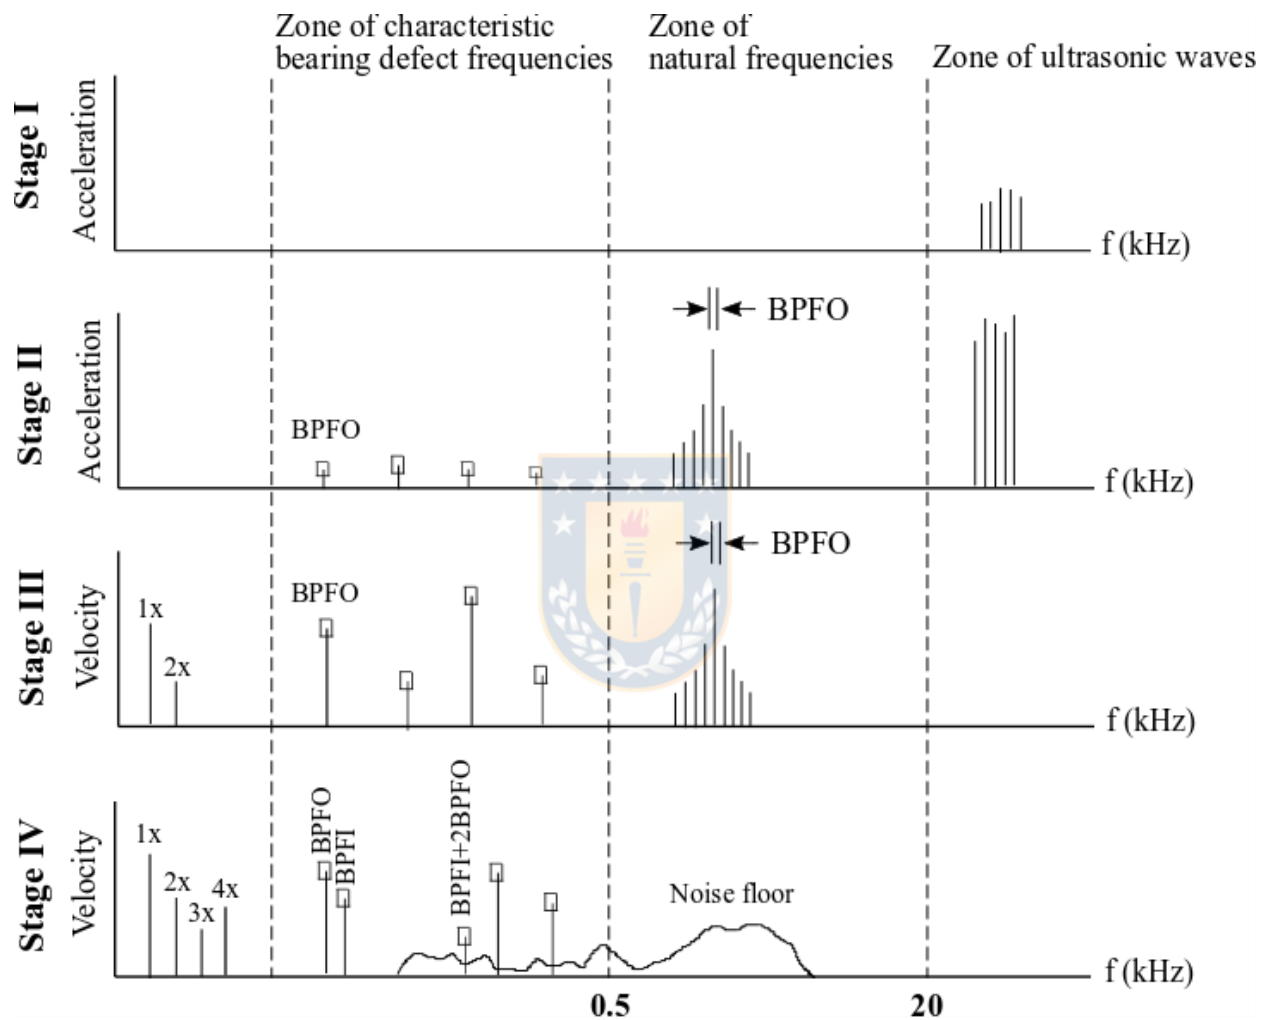
Figure 11. Stages of typical bearing fault development.

A bearing fault usually develops in different stages, and consequently that affects the diagnostic procedure. A bearing defect can be categorized in four stages depending on the size of the defect [Saavedra 2005].

At the first stage the defect starts frequently as a crack developing below the surface of the material. As the rolling elements pass over the defect, encouraging the crack to develop, the bearing material is excited and ultrasonic waves are produced. In this stage a bearing defect can be identified only by techniques that work efficiently at high frequency regions, that means over 20 kHz. On example for such a technique is the acoustic emission (AE) analysis.

As the defect develops, and the bearing's structural integrity is compromised, impacts are produced when the ball passes over the defect. If the impacts excite bearing or sensor natural frequency (generally between 1 kHz and 5 kHz) the energy level starts to increase. In this case the envelope analysis, which is explained in section 4.4, and a high frequency acceleration (ACC) spectrum can pinpoint the bearing fault. A low frequency velocity spectrum will still not show clear evidence.

At the final stage of a bearing defect a significant damage is present. The vibration spectrum noise floor will start to raise and it is almost impossible to detect the characteristic frequencies of the bearing defects. Machines with bearings in final stage should not be operated as a catastrophic failure can be imminent.

This typical bearing fault development in stages can be observed graphically in Figure 11.

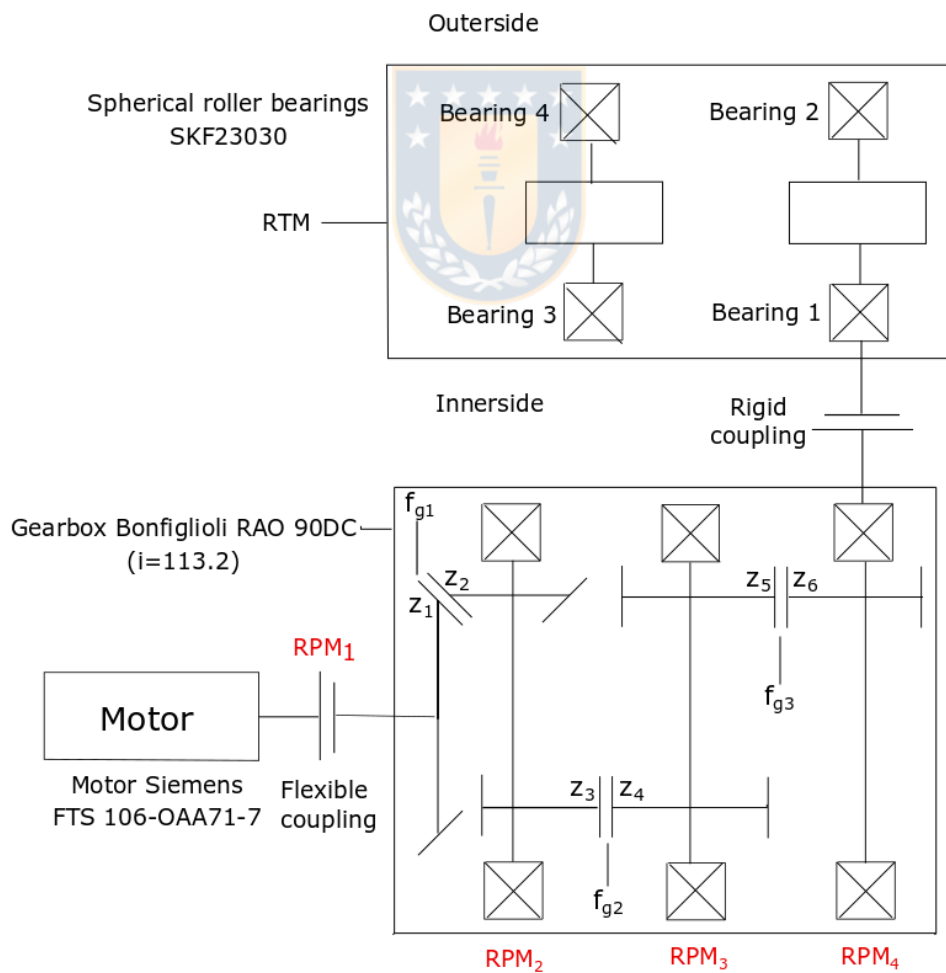
Figure 12. Data sheet of the RTM.

The data sheet of the RTM is presented in Figure 12.

The number of teeth of each gear wheel in Figure 12 is shown in Table 5.

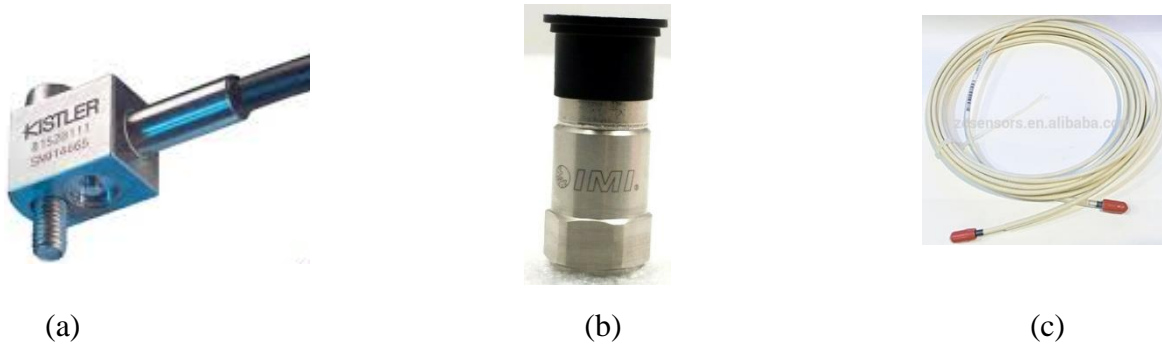
Figure 14. Measurement sensors. (a) Kistler wideband sensor. (b) IMI vibration sensor. (c) Bently Nevada proximitors sensor.

The sensors are shown in Figure 14 and the data sheets of the Kistler and the IMI sensor are presented in Appendix A.

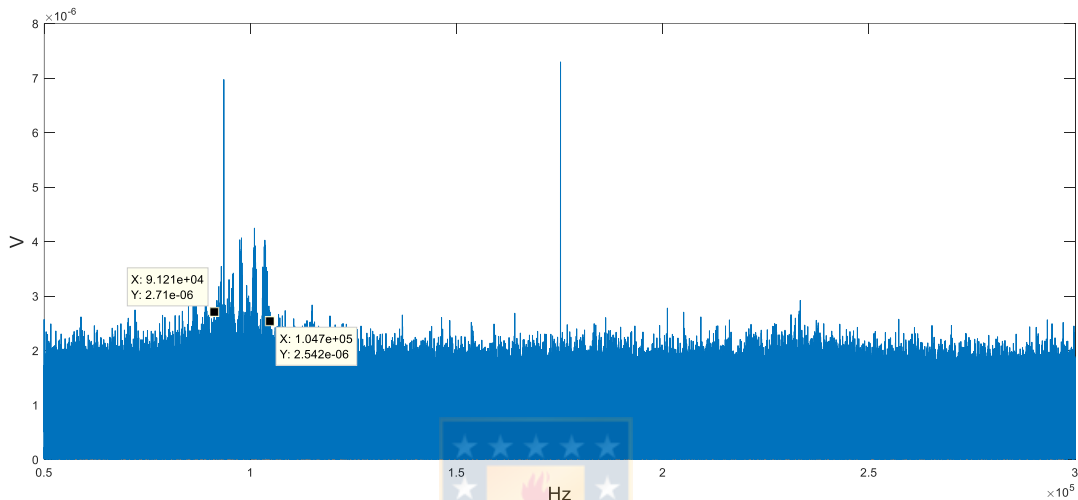
Figure 20. FFT spectrum of AE, UT2-RTM 3-bearing 2, analysis period: 92 s to 110 s.

The high frequency FFT spectrum of the AE is shown in Figure 20. This spectrum helps to choose a filter before applying the AE envelope spectrum by observing high frequency energy areas. As marked in the figure a filter around 98 kHz is used. The fast kurtogram was also used as an alternative to select the most suitable frequency band for demodulation. Fig. 21 shows the kurtogram where is seen that the Kurtosis (i.e. the impulsiveness feature of the signal) is maximum in the band from 21.972 kHz to 22.460 kHz. The decomposition level 10 means that the signal is progressively decomposed via a filter bank

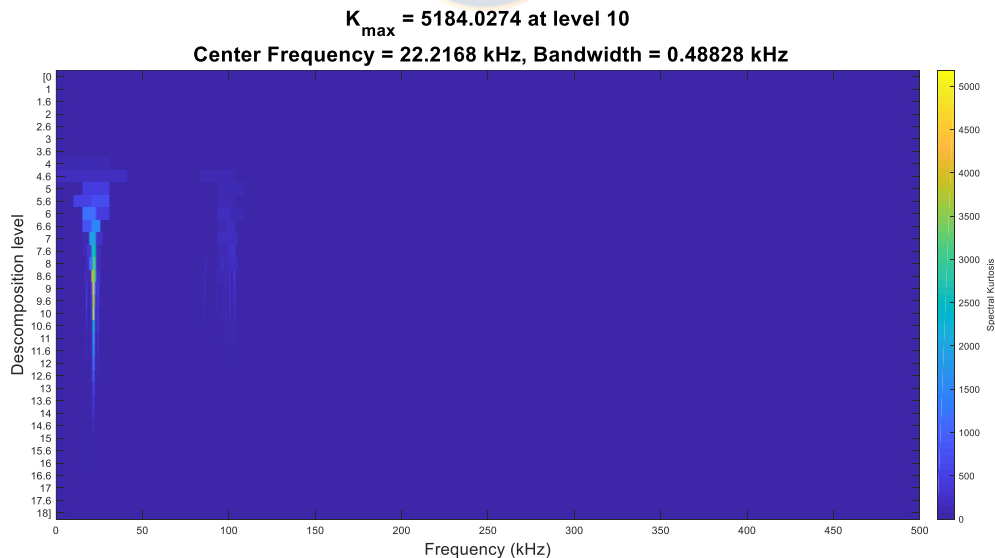
Figure 21. Kurtogram of AE.

structure in $2^{10} = 1024$ frequency bands and the SK is calculated at each band. The color bar shows the range of SK values. As the indicated center frequency of 22216 Hz is outside of the AE sensor frequency range mentioned in section 5.4, the AE spectrum is only filtered around 98 kHz. Figure 22 shows the resulting envelope of the AE, whereas the filtered envelope spectrum can be observed in Figure 23. The same results shown in Figure 18 and 19 are obtained, the filter in this case only enhance the characteristic bursts.

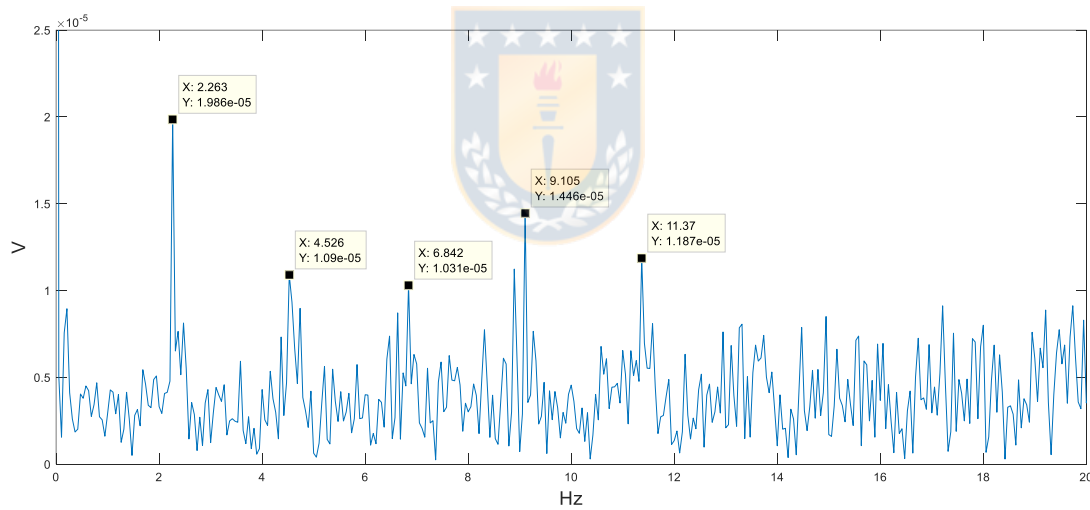
Figure 22. Envelope of filtered AE (center frequency: 98 kHz).

Figure 23. Filtered envelope spectrum of AE (center frequency: 98 kHz).

In summary, the acoustic emissions of the bearing 2 of the RTM 3 (UT2) show signs of an incipient defect in the outer race, which acceleration vibration and displacement vibration do not reveal. Probably it is an incipient bearing failure (stage I) where the defect can be identified only by techniques that work efficiently at high frequency regions, how it does the AE analysis. Lubricant analysis is recommended, as well as periodic monitoring of the bearing defect.

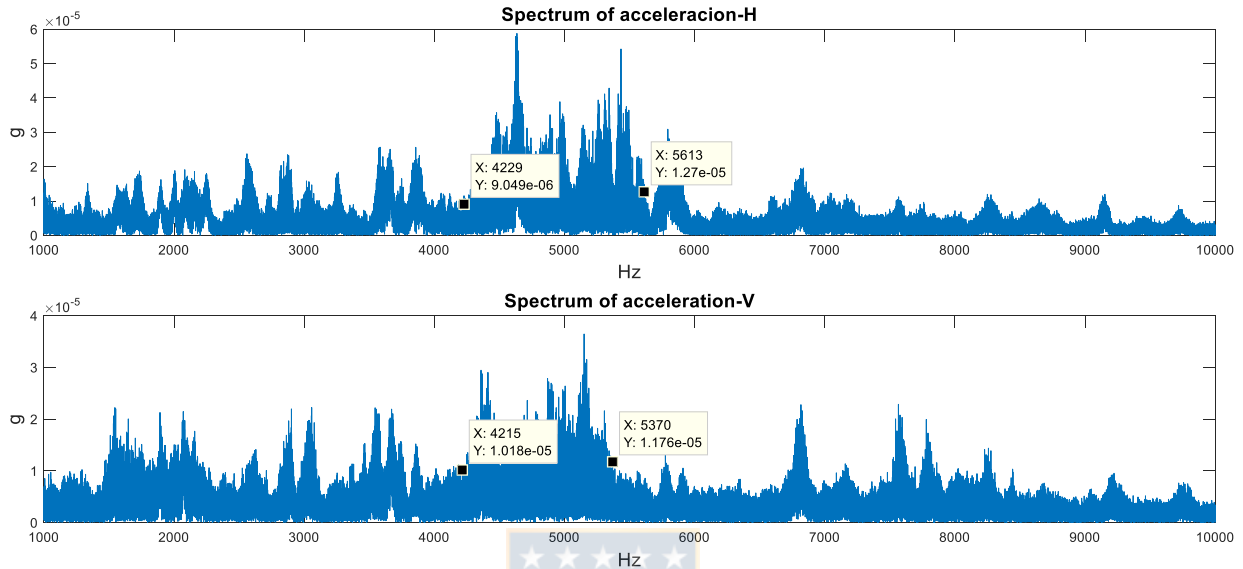
Figure 24. Acceleration high frequency spectra with marked filter ranges.

Next the acceleration high frequency spectrum has to be analyzed because of the possibility that the bearing defect is in stage II. The ACC-H and ACC-V spectra can be observed in Figure 24. As detailed in section 6.3 especially in slow-speed bearings it is difficult to observe clear spectral components at the defect frequencies. Therefore, the envelope detection is used as explained in section 6.4 to improve the signal-to-noise ratio and make the spectral analysis more effective. As the efficiency of this method depends strongly on the choice of the most impulsive band for demodulation, the zones of resonance frequencies in the acceleration spectra obtained applying the FFT are filtered. Center frequency and bandwidth are determined by observing high-energy frequency areas in the acceleration spectrum.

Figure 24 shows filter examples of the high frequency acceleration spectrum. In this case the ACC-H spectrum is filtered between 4229 Hz and 5613 Hz, whereas the filter range of the ACC-V spectrum is 4215 Hz to 5370 Hz. More filter ranges were used, but did not reveal different results.

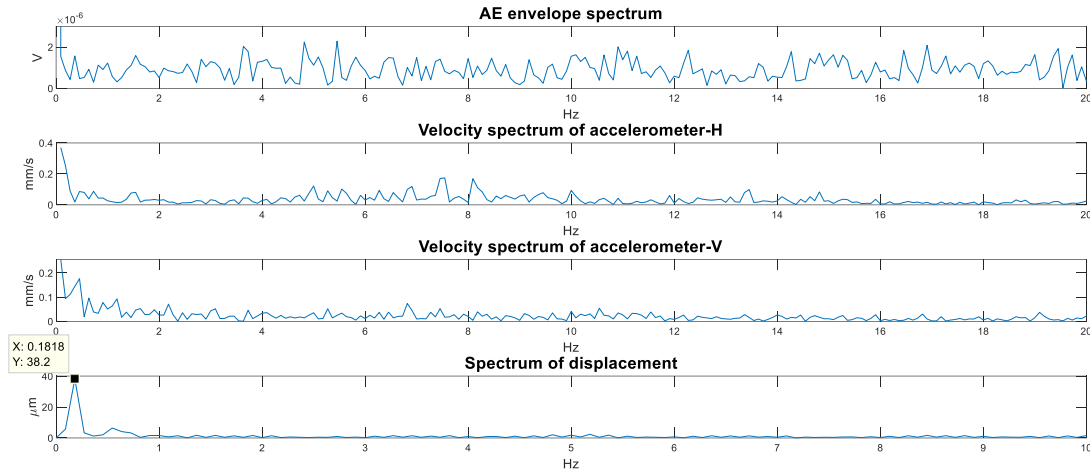
The results obtained in section 7.3.1 are valid for the most part of the totally 279 seconds measured of the bearing 2 of the RTM 3. But between the sections which show the characteristic bursts clearly in the waveform and the unfiltered AE envelope spectrum, there are some sections where these bursts are not visible. One example is the period between 120 s to 130 s. No bursts can be observed in the waveforms as shown in Figure 29, neither in the different spectra in Figure 30. The RPM obtained from the displacement spectrum has a value of 0.1818 Hz. That means that the rotational speed of the RTM wheel shaft changed with regard to the first analysis period. This is expectable in slow-speed machines. The resulting CDF are shown in Table 11.

Figure 29. Waveforms, UT2-RTM 3-bearing 2, analysis period: 120 s to 130 s.

Figure 30. Spectrum analysis without filter, UT2-RTM 3-bearing 2, analysis period: 120 s to 130 s.

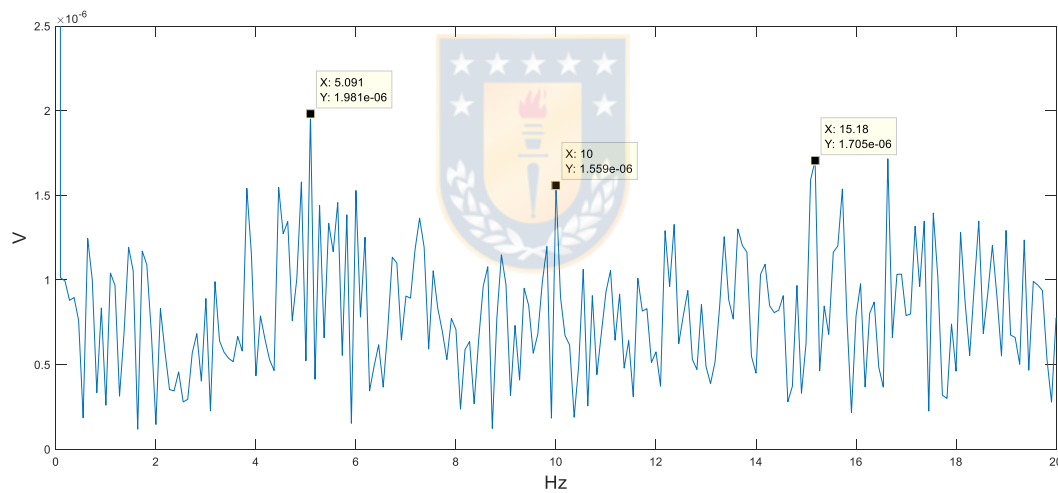
In summary, there are sections of the measurement where the bearing defect is not detectable probably due to the incipient defect. Therefore, a sufficient record time during the measurement is very important.

Figure 31. FFT spectrum of AE, UT2-RTM 3-bearing 2, analysis period: 120 s to 130 s.

Figure 32. Filtered envelope spectrum of AE (center frequency: 98 kHz).

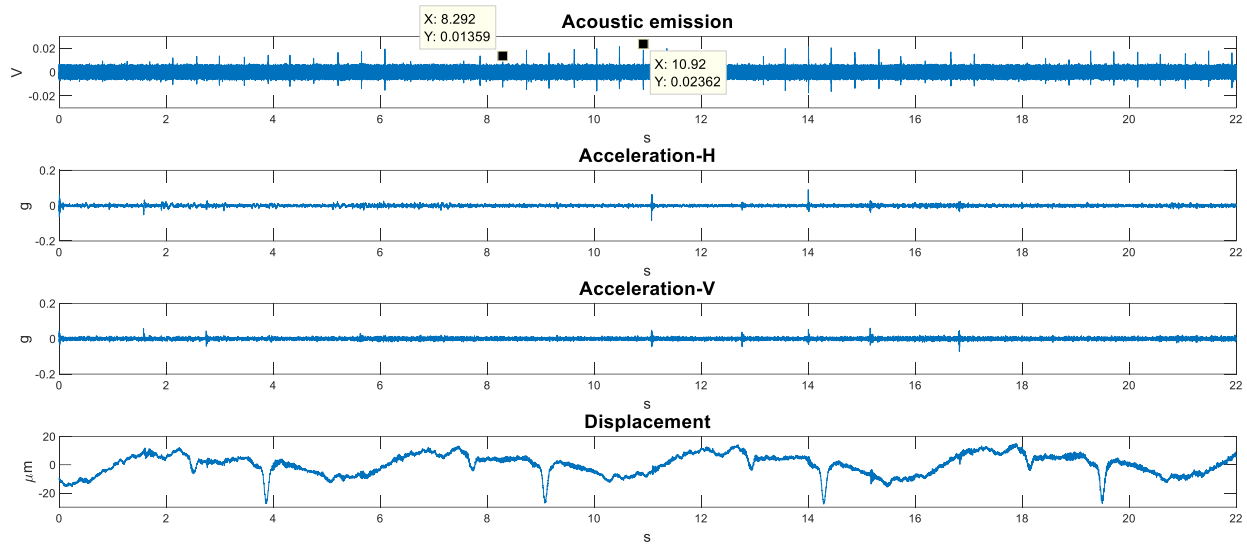
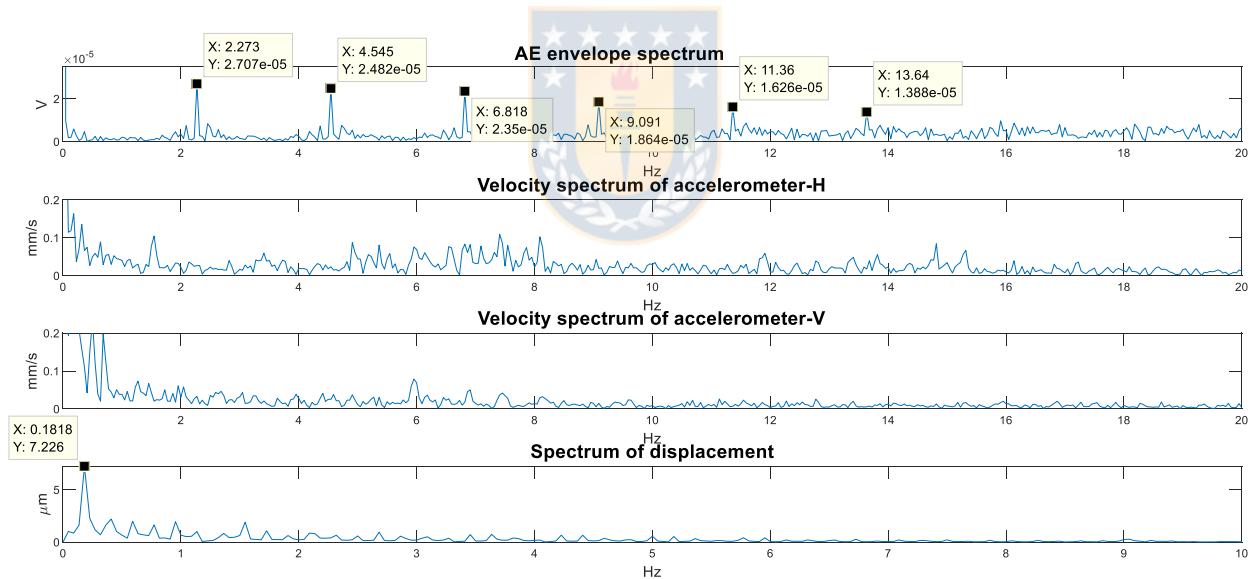
The analysis of this bearing is performed in the same way as explained in section 7.3.1. Figure 33 shows the waveform of all measured variables and Figure 34 the different spectra without filter.

A periodic succession of bursts separated by 0.44 s can be observed in the AE waveform. This period is associated with the BFO as indicated in Table 12 considering again the possibility of a slightly difference between the calculated and measured value as explained in section 7.2. The difference between the two values in this case is 2.3%, which is within the expected range. Comparing the amplitude of the bursts with those shown in Figure 18, it can be observed that the amplitudes in this case are considerably
